Comparison Testing - Photo Journal

Genuine CQR

Manson Plough (CQR copy)

Rocna

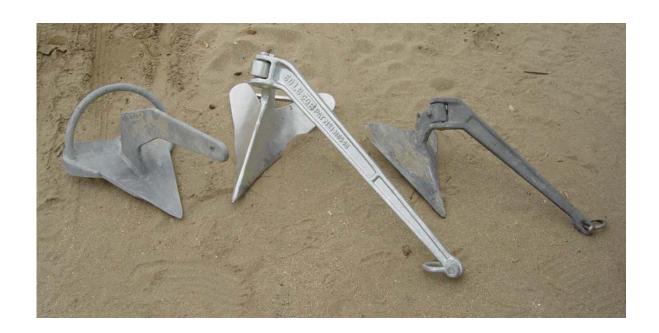
Testing methodology: straight line pull tests behind motor vehicle. Wet sand used at a beach with low surf activity.

Aim: Testing of given anchors' *reliability*, i.e. <u>setting performance</u>. Accordingly no measurement was made of resistance.

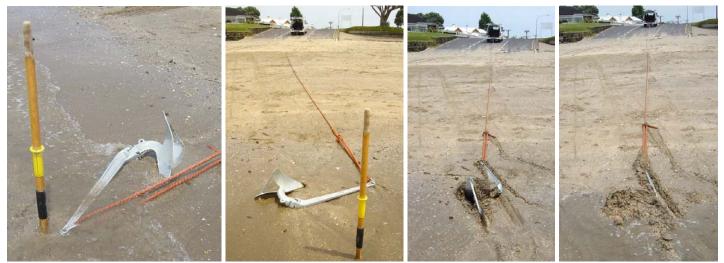
Turn through to set. No problems.

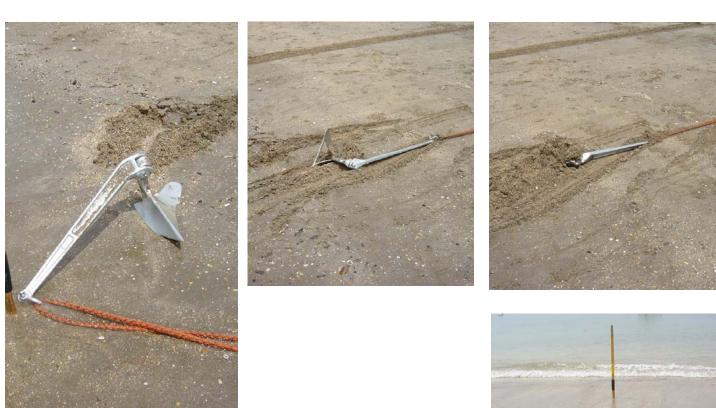
Quick set. Fluke does not right itself 100%.

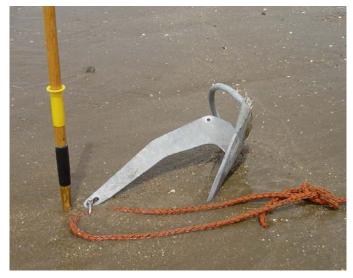
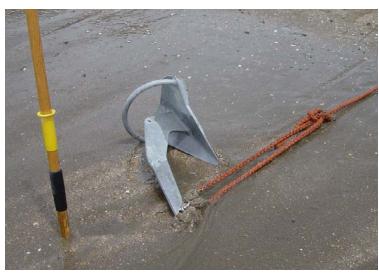
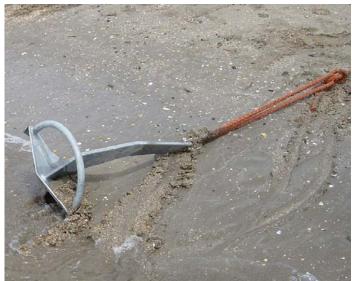
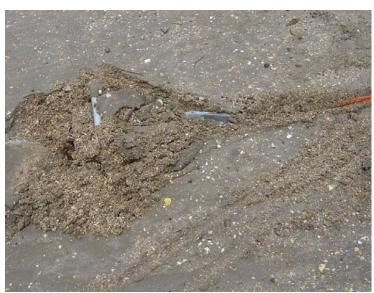
Instant set and burial

No drag even as load is increased. Rode failure before yield.

Sand has been cleared away by hand from buried anchor.

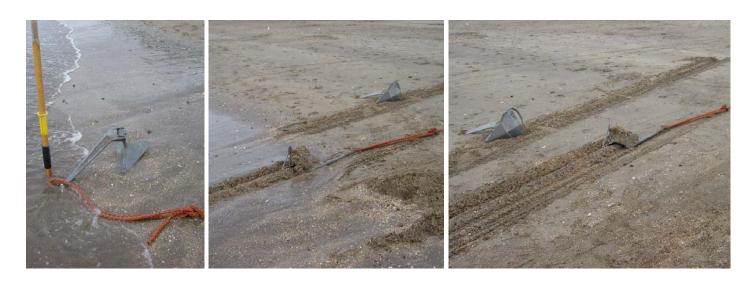
No set

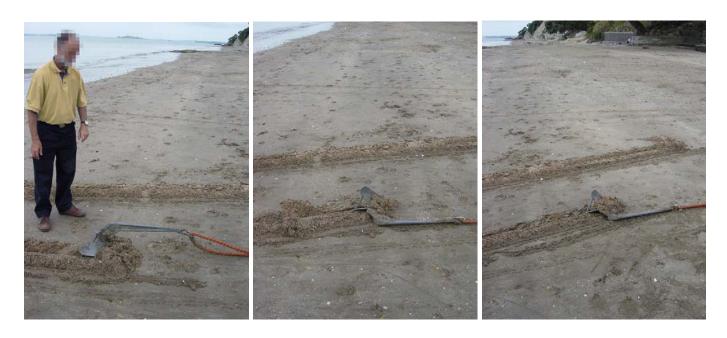
One last time, this time manually placed upright:

No set
